**TANKS ILLUSTRATED NO. 9**

# Last of the **Panzers**

**German Tanks 1944-45**

**WILLIAM AUERBACH**

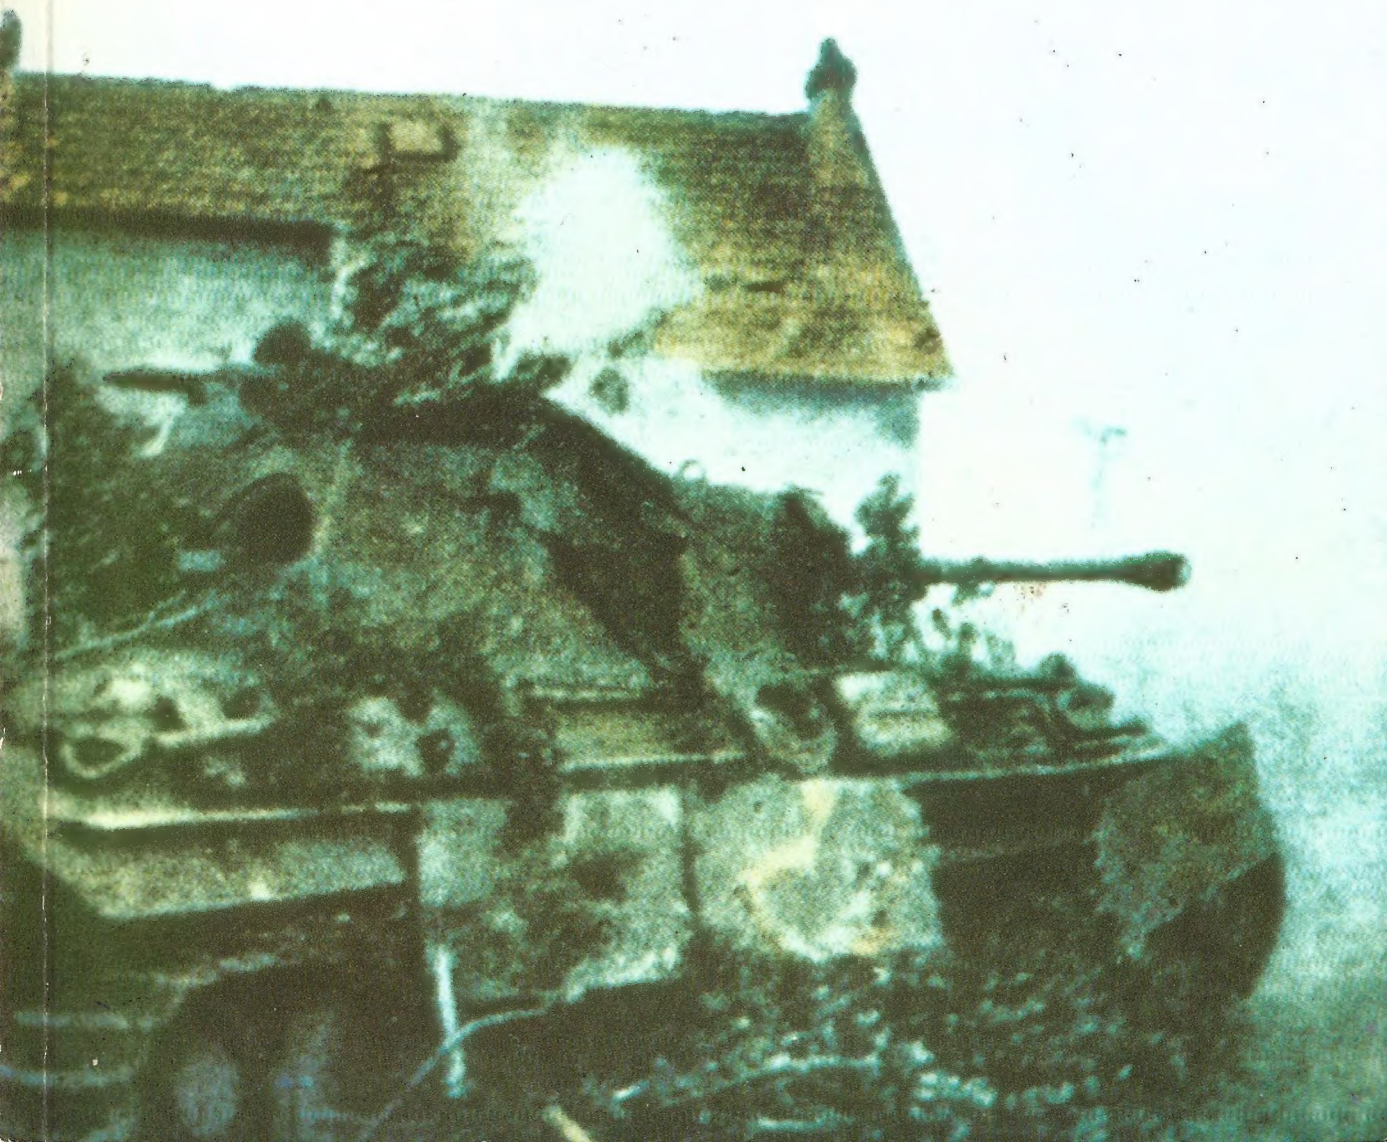
1. A totally destroyed Pz Kpfw IV Ausf H rests in a field near Vaucelles, France, 18 July 1944, its high-velocity 7.5cm still defiantly spiking the sky. (PA-114368/Public Archives of Canada)

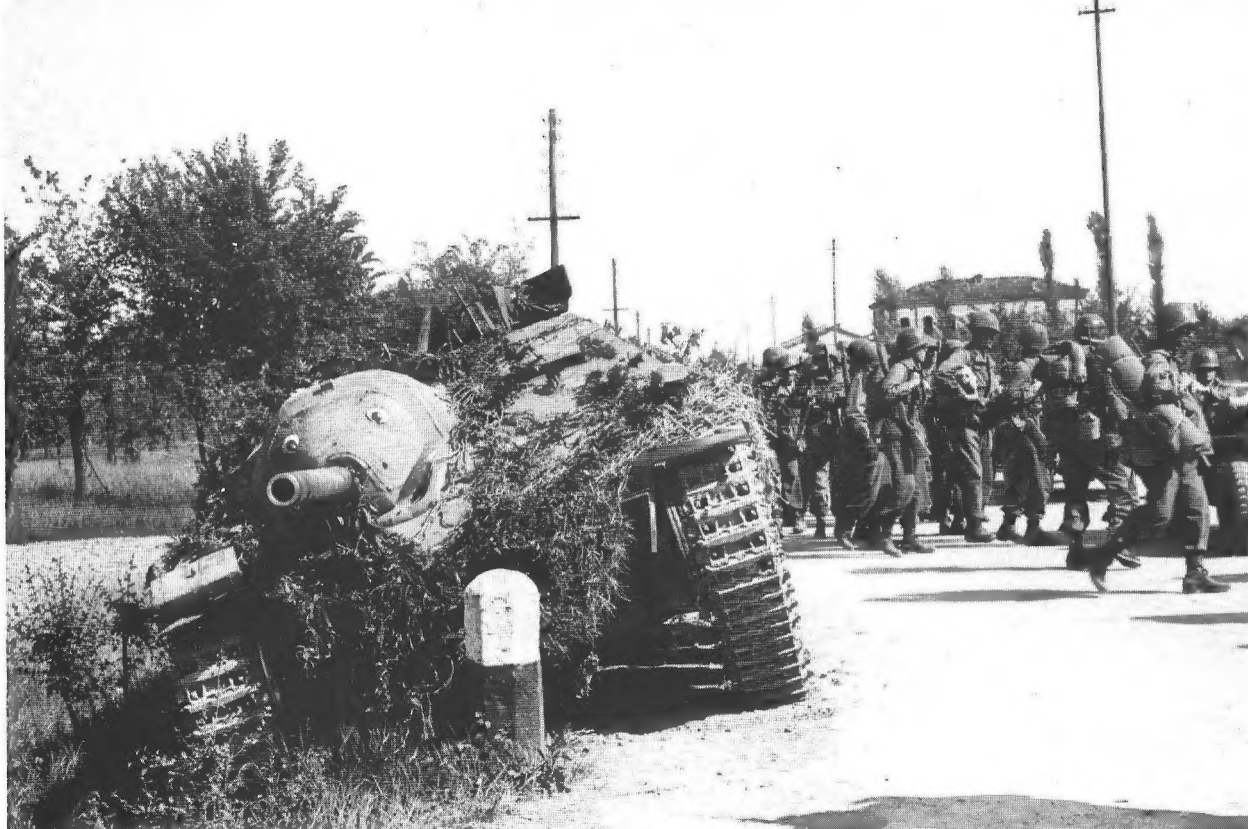
▲3 ▼4

**3.** American infantrymen of the 133rd Regiment, 34th Division, US Fifth Army, passing a Jagdpanzer 38(t) Hetzer on Highway 9, Modena, Italy, 23 April 1945. The mantlet, roughly finished and decorated with two 'eyes', identifies the vehicle as a late model. The sloping lower hull sides are very evident, as is the large amount of foliage draped on the vehicle for added camouflage. The auxiliary remote-controlled MG42 sights have been removed by its crew.

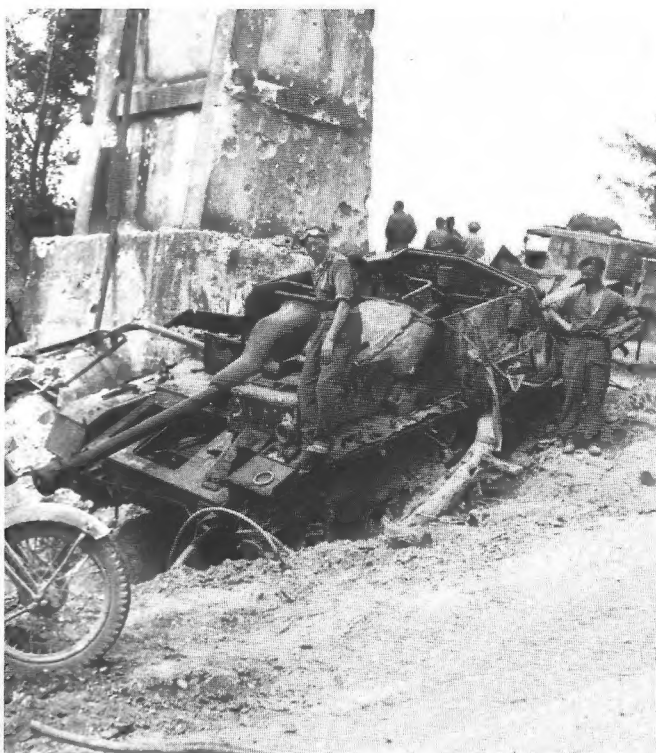
5▲

**5.** The heavy fighting which took place near Pontecorvo, Italy, is reflected in the devastation surrounding this StuG IV knocked out by the 48th Highlanders, 19 May 1944. The concrete reinforcement on the driver's cab is cracked, and additional armour plate appears to have been fitted to the side of the cab. Note the hinged sun visors on the driver's periscopes and the additional armour bolted to the right front superstructure which may also have been covered with concrete. (PA-130353/Public Archives of Canada)

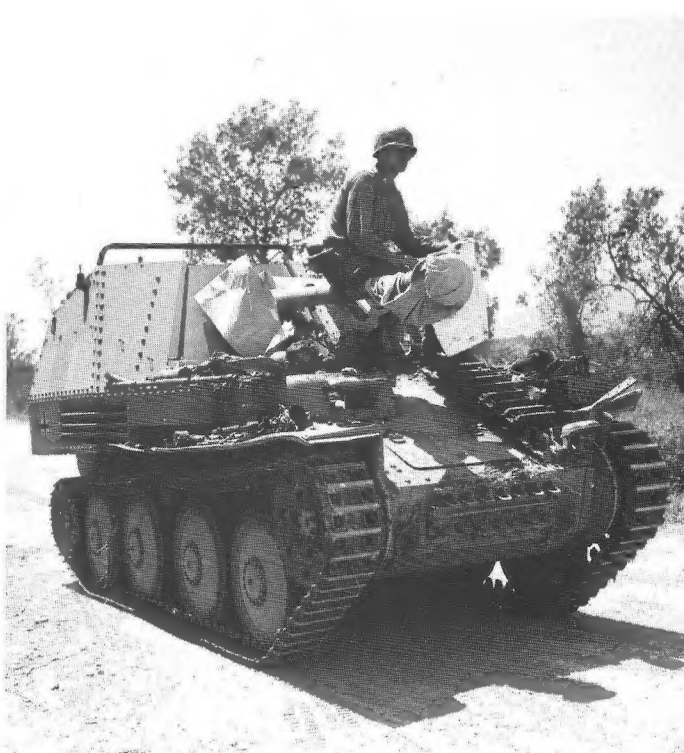
6▲ 7▼

**6.** In the Castellonorato area of Italy, 16 May 1944, troops of the Anti-Tank Company, 85th Division bring in a captured Panzerjäger 38(t), giving an idea of the small size of this vehicle. This Marder III has the rounded, cast cover for the driver's compartment and only one return roller.

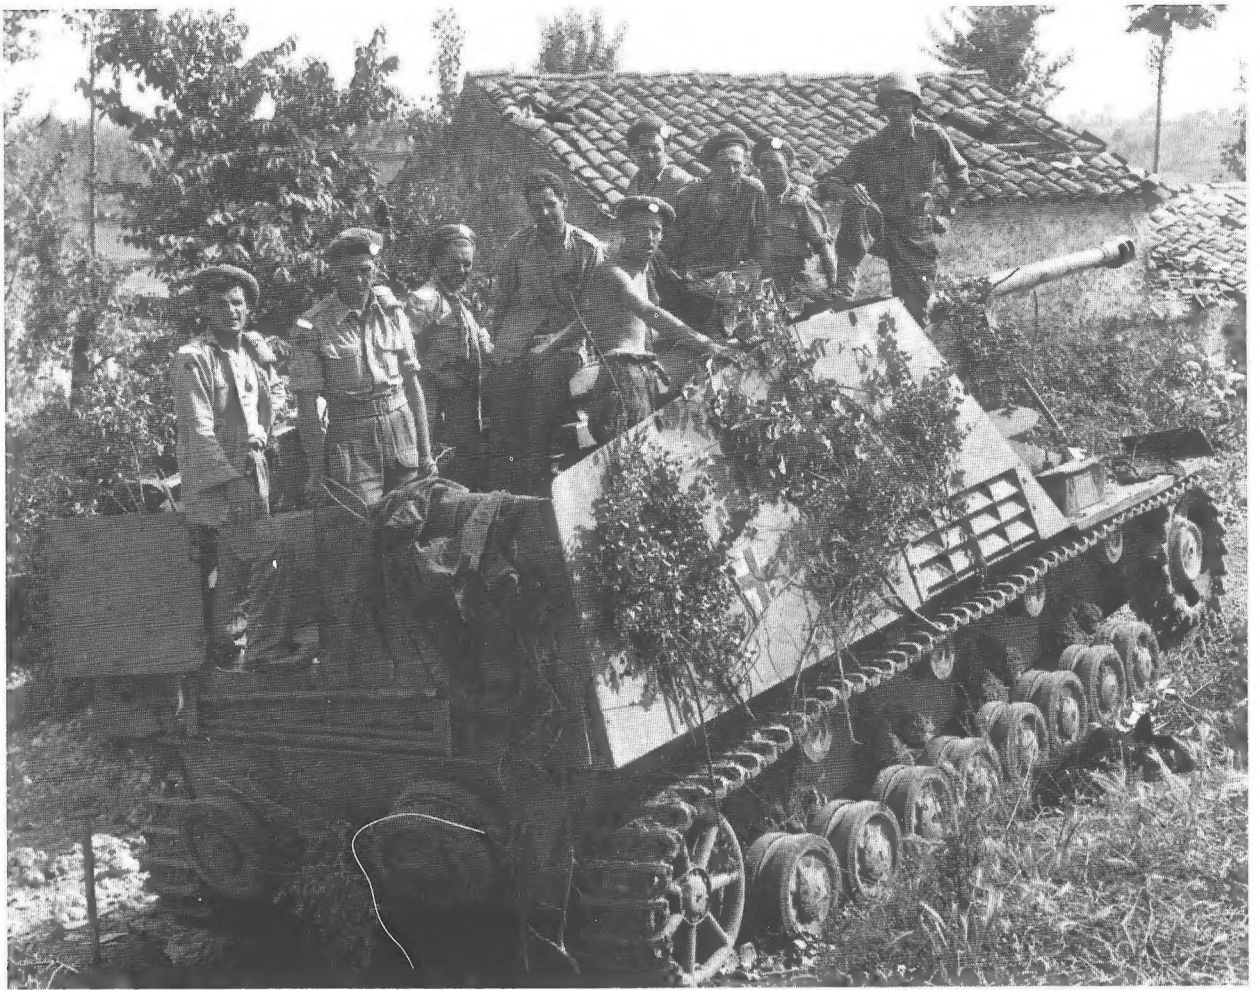
10▲ 11▼

10. The 5th Canadian Armored Brigade was credited with this 'Nashorn' knocked out by a PIAT near Pontecorvo, Italy. The gun is still secured in its travel lock, indicating that the crew was caught by surprise. Unusual is the fact that the rear tow hooks are missing from both sides. Note the number '2' painted on the rear plate. The photograph was taken on 26 May 1944. (PA-130348/Public Archives of Canada)

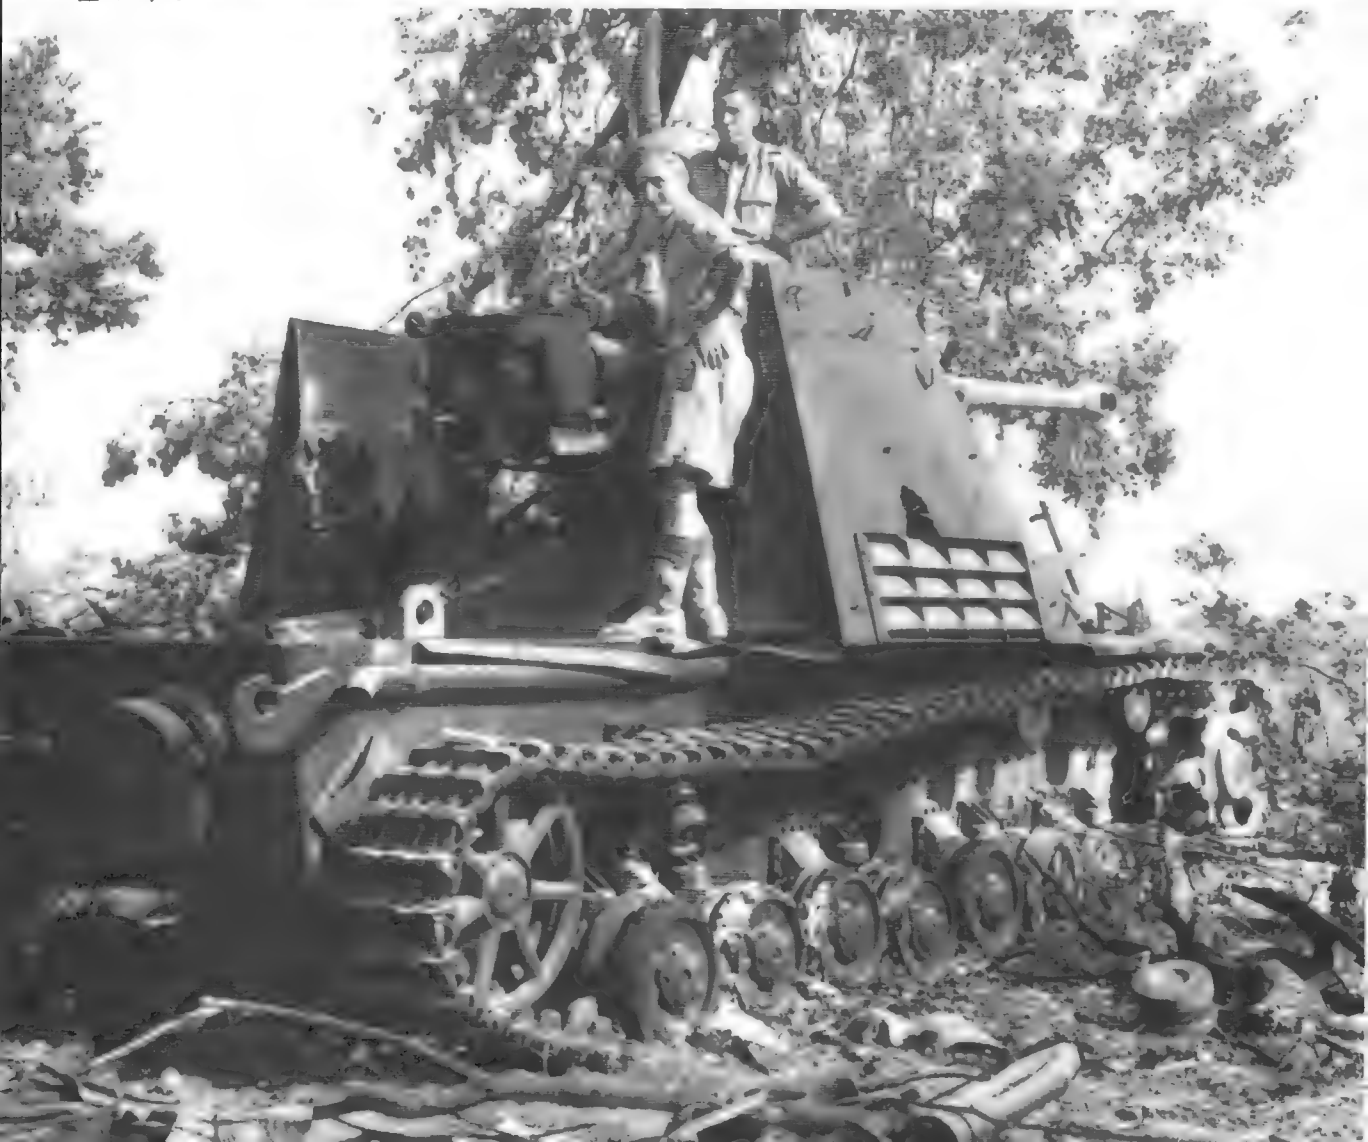
13. Members of a Canadian light AA regiment look over a 'Nashorn' near Pontecorvo, Italy, 30 May 1944. The armour on the fighting compartment has been blown away revealing the mount for the 8.8cm PaK43/1. Note the plate behind the idler that pushed loose track pins back into position. (PA-130346/Public Archives of Canada)

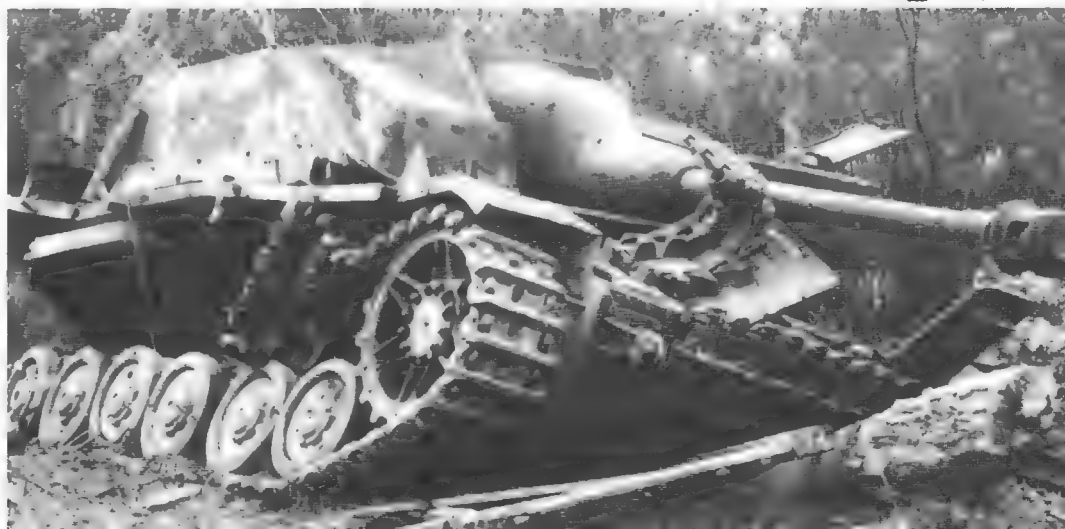
**17.** This burned-out Panther Ausf A was found blocking a road near Marigny-Montrevil, France, the day after being attacked by rocket-firing aircraft. A Pz Kpfw IV Ausf H or J mired itself trying to go round it. (US Air Force Photograph)

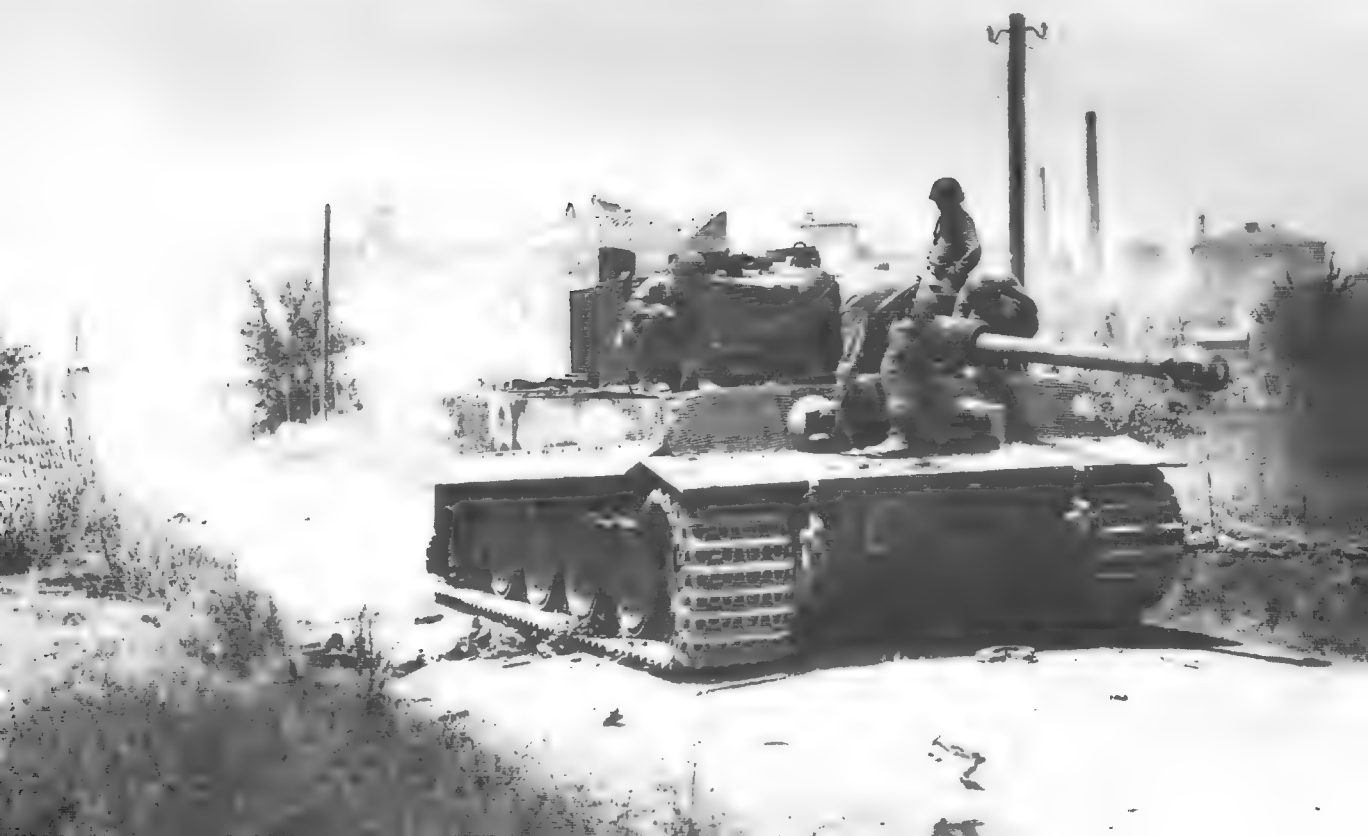
**18.** GIs of the 133rd Infantry Division examine a Tiger I Ausf E, stopped by a 75mm round in the flank, during a counterattack in the Cecina area of Italy, 3 July 1944. This late-production model, with the new cupola and resilient steel wheels, has a thick layer of zimmerit on the turret, of a different pattern from that on the rest of the vehicle.

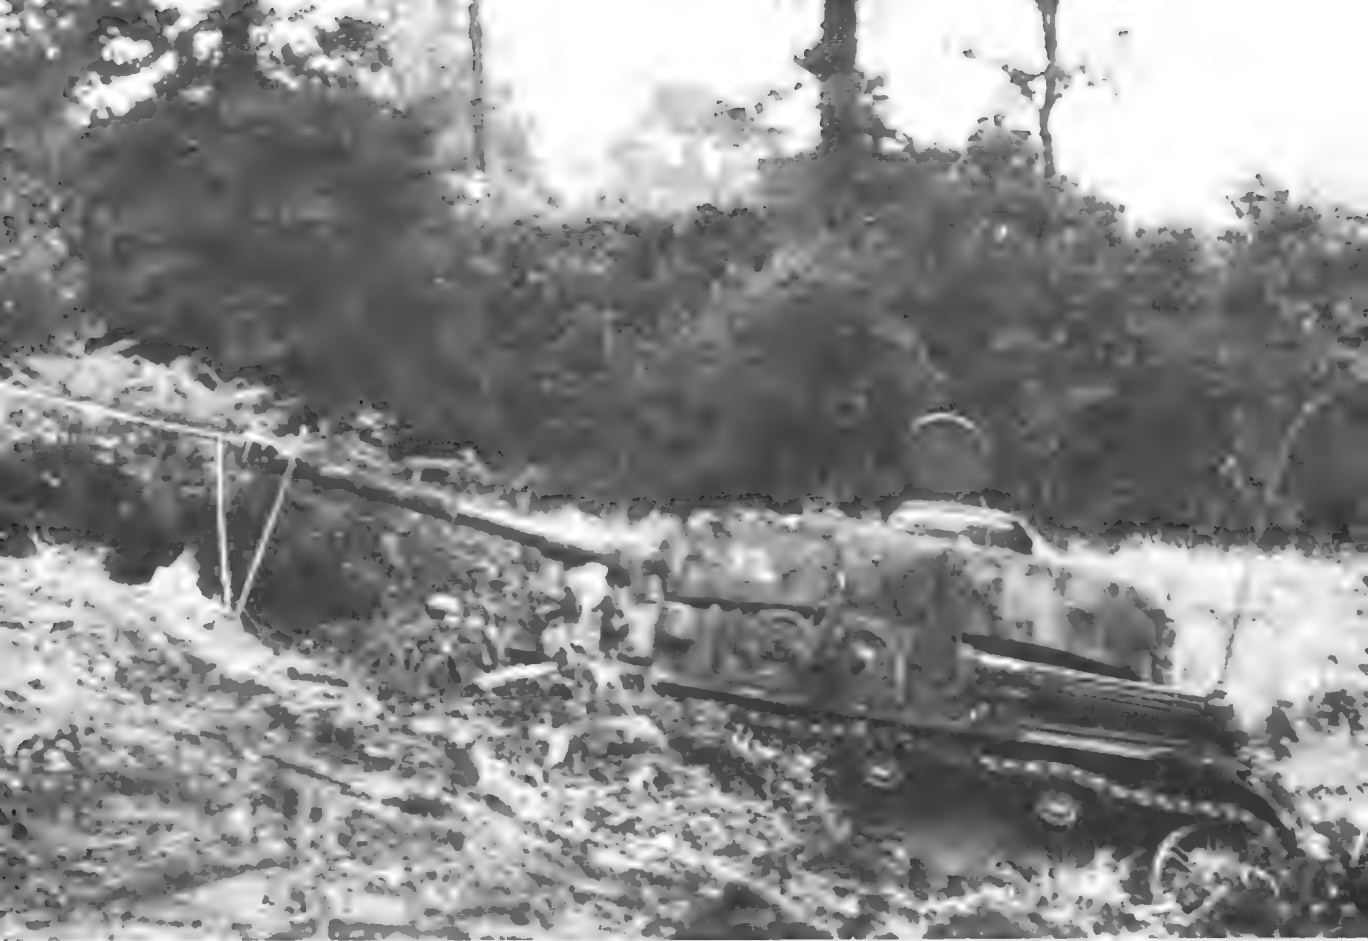
19▼

**19.** Sturmgeschütz IV caught in the bocage by rocket-firing aircraft and put out of action near Marigny-Montrevil, France. The hatches over the driver's cab and commander's cupola are open. The vehicle has zimmerit, and a spare track on the hull front and driver's compartment. (US Air Force Photograph)

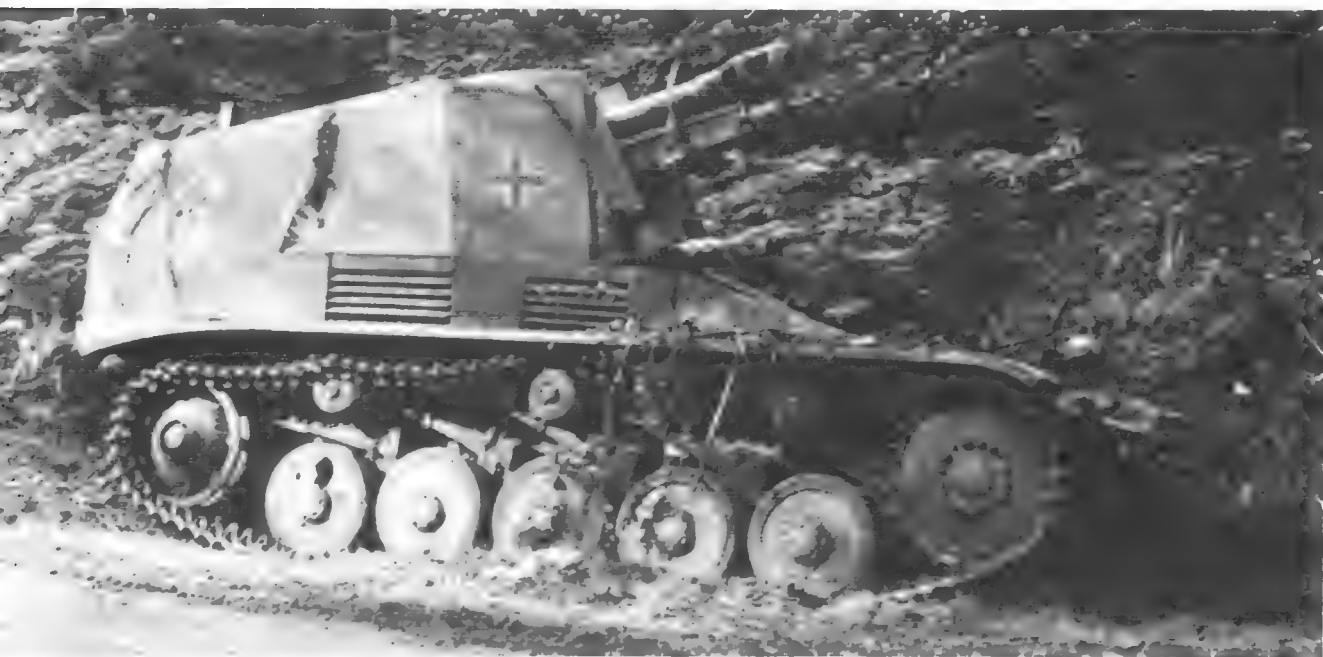
▲20 ▼21

20. In the Canadian sector a 'Wespe' turns up, disabled with its howitzer jammed in full recoil. The redesigned air louvres of this SP fit right into the sides of the superstructure, giving the vehicle very clean lines. German crosses are carried on both sections of the shield. The tracks, unusually, are installed backwards. (Author's collection)

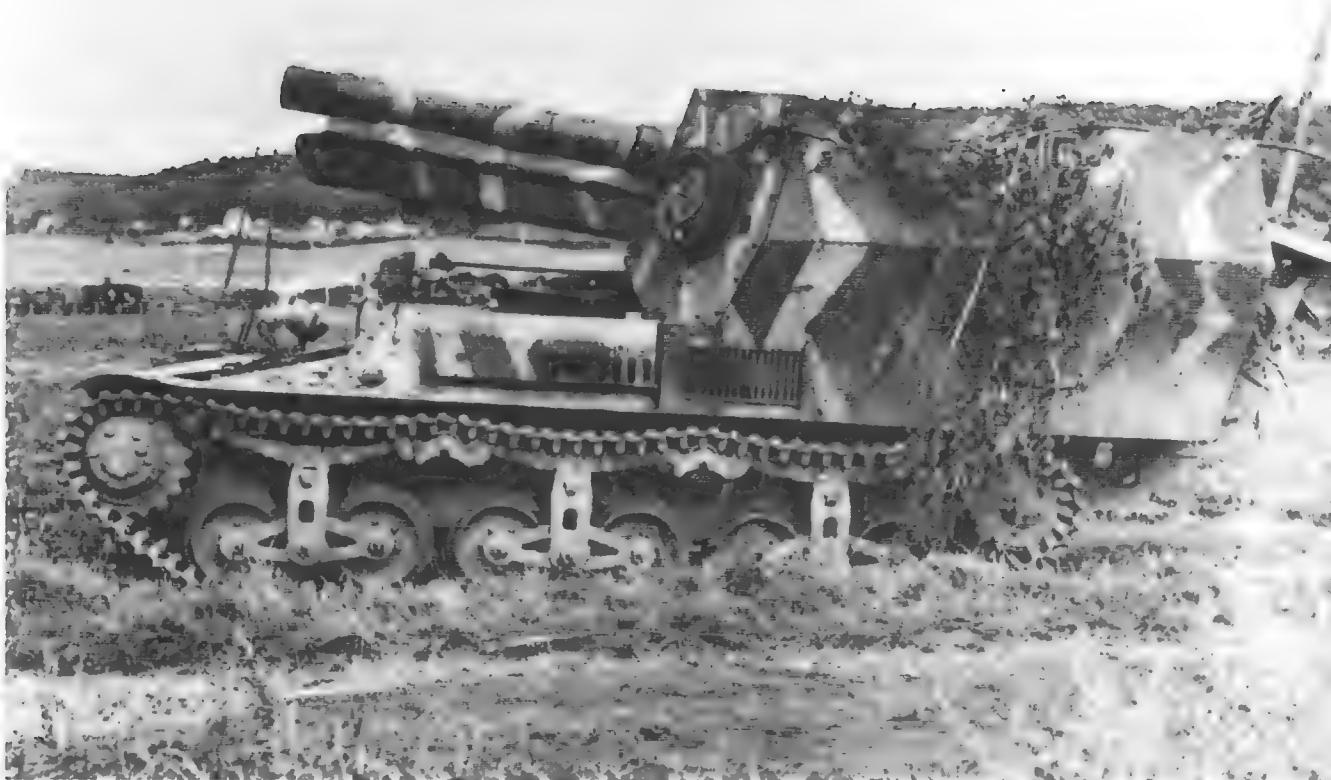
22▲

22. One of fifty-four 15cm sFH13/1(Sf) auf GW Lorraine Schlepper (f)s still available to the Germans in 1944, appears in dazzling splinter camouflage in the Canadian sector soon after the invasion. The recoil spade is in the raised position and the vehicle number is obscured by foliage draped over its side. (Author's collection)

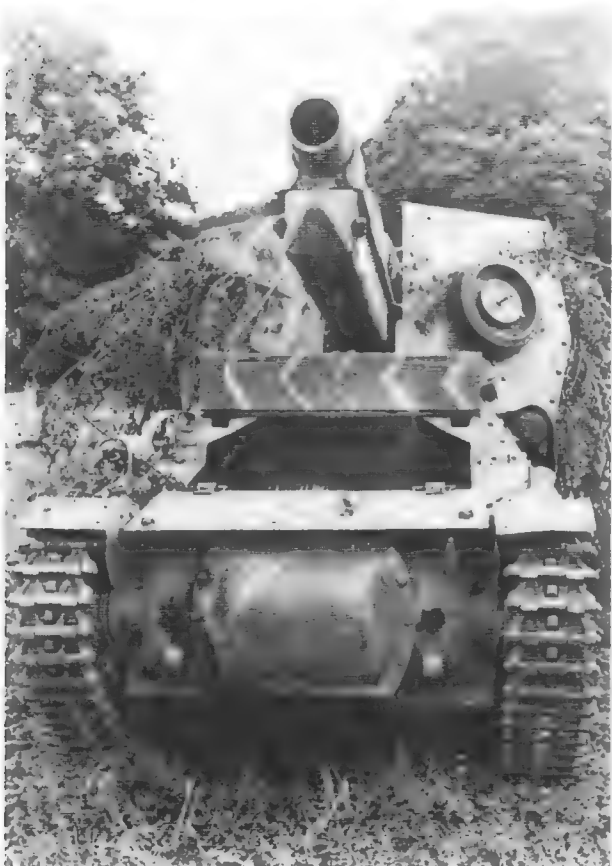
◀23

23. Front view of the same vehicle showing the driver's compartment wide open. The travel lock is folded down directly behind the visored flap. (Author's collection)

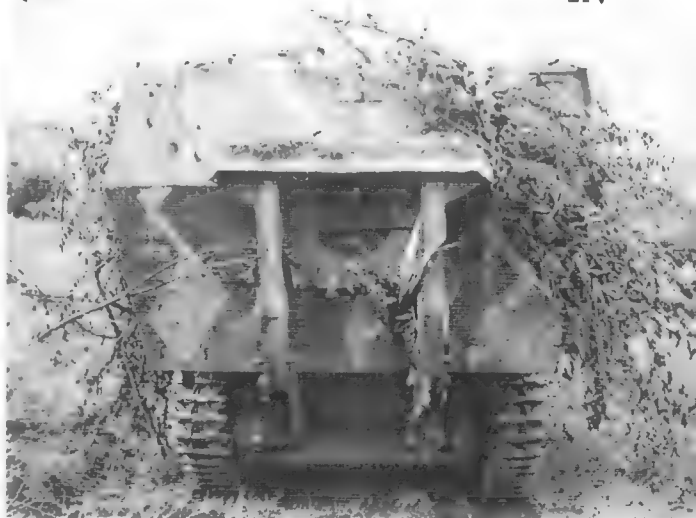
24▼

24. Rear view showing the lengthened recoil spade and access door. Note the chain used to raise and lower the spade, and the symbol indicating a fully-tracked artillery vehicle. (Author's collection)

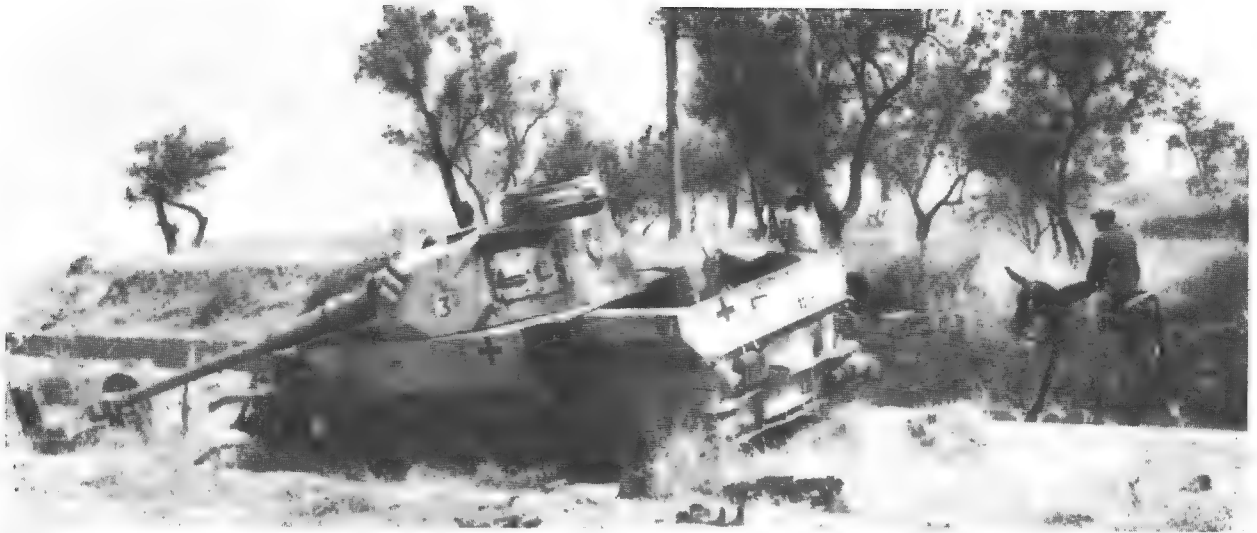
▲25

25. A thoroughly crippled Pz Kpfw IV Ausf G litters the Agira-Regalbuto road near Pachino Beach, Sicily, 3 July 1944. Its distinguishing features are the side vision port for the driver and the smoke dischargers on the turret front. The conical pistol port, which is normally overshadowed by the rear stowage bin, is plainly visible in this photograph. (PA-130337/Public Archives of Canada)

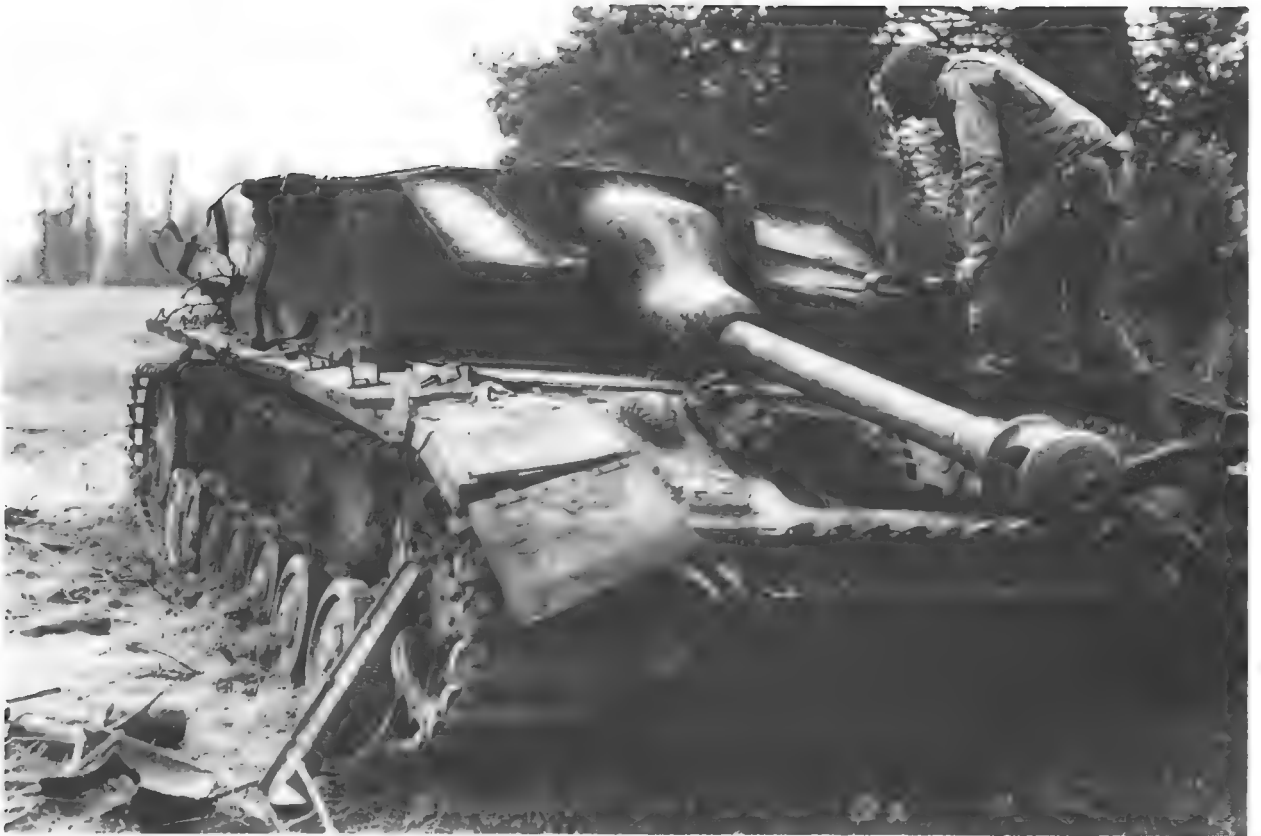
27▲ 28▼

28. A rather dishevelled FlaKpanzer 38(t) and the possibility of snipers are all that threaten US troops in Torigni-sur-Vire, France, 3 August 1944. The vehicle has the early cast cover for the driver's compartment bolted on the glacis. A shop sign in the background appears to be part of the 2cm FlaK38 mount.

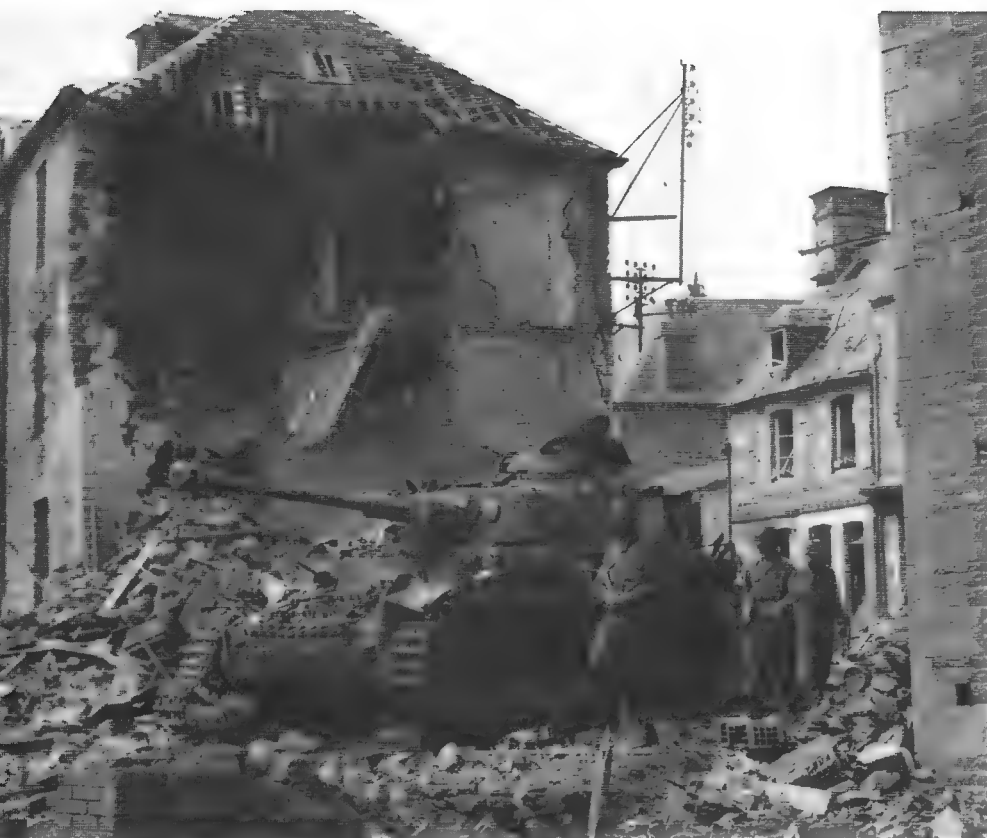
▲29 ▼30

**29.** A patrol from the 35th Infantry Division follows up an American artillery barrage into Pontfarcy, France, 3 August 1944, passing a Pz Kpfw IV Ausf H amid the ruins. The vehicle's right track is broken and dust obscures the German cross and stenciled outlines of the number '802' on the turret schurzen. The hull armour is interlocked, the driver's side visor is absent and the muzzle brake is of the late, round pattern. Note the early sprocket/idler in combination with four steel return rollers.

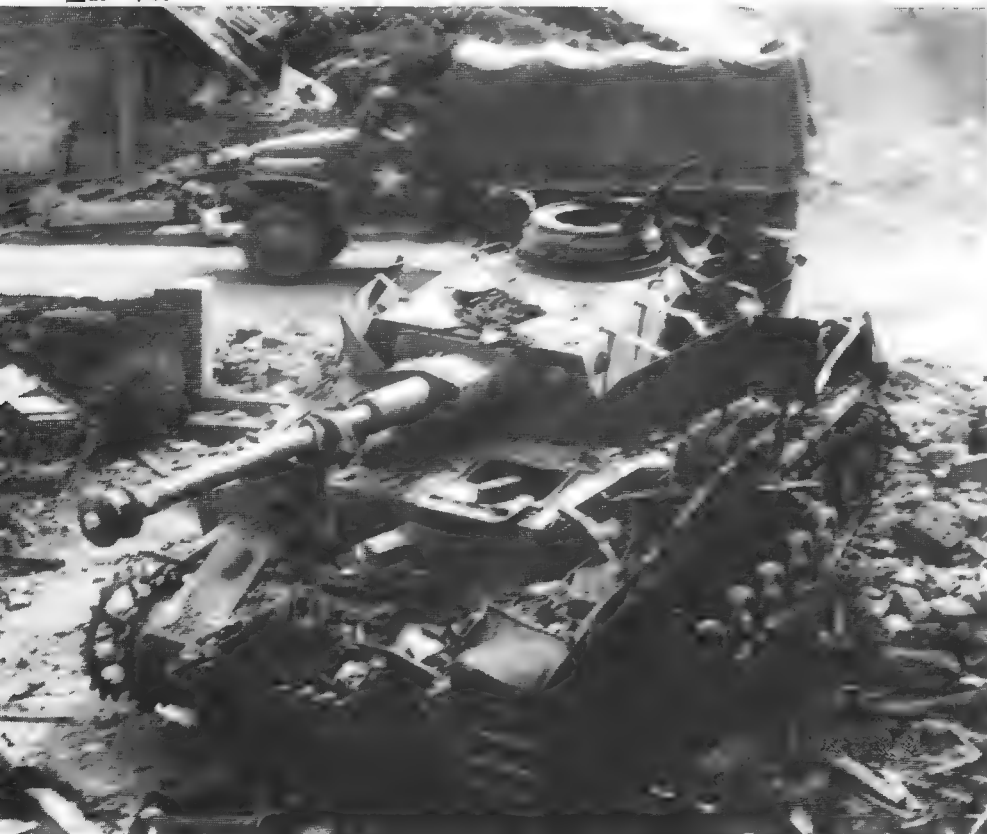
**30.** The same vehicle photographed two days later from a different angle shows the pistol ports in the turret doors and the 'Nahverteidigungswaffe' on the turret roof, but no lugs for the 2-ton crane. The 2nd Panzer Division's trident insignia appears on the left front superstructure corner.

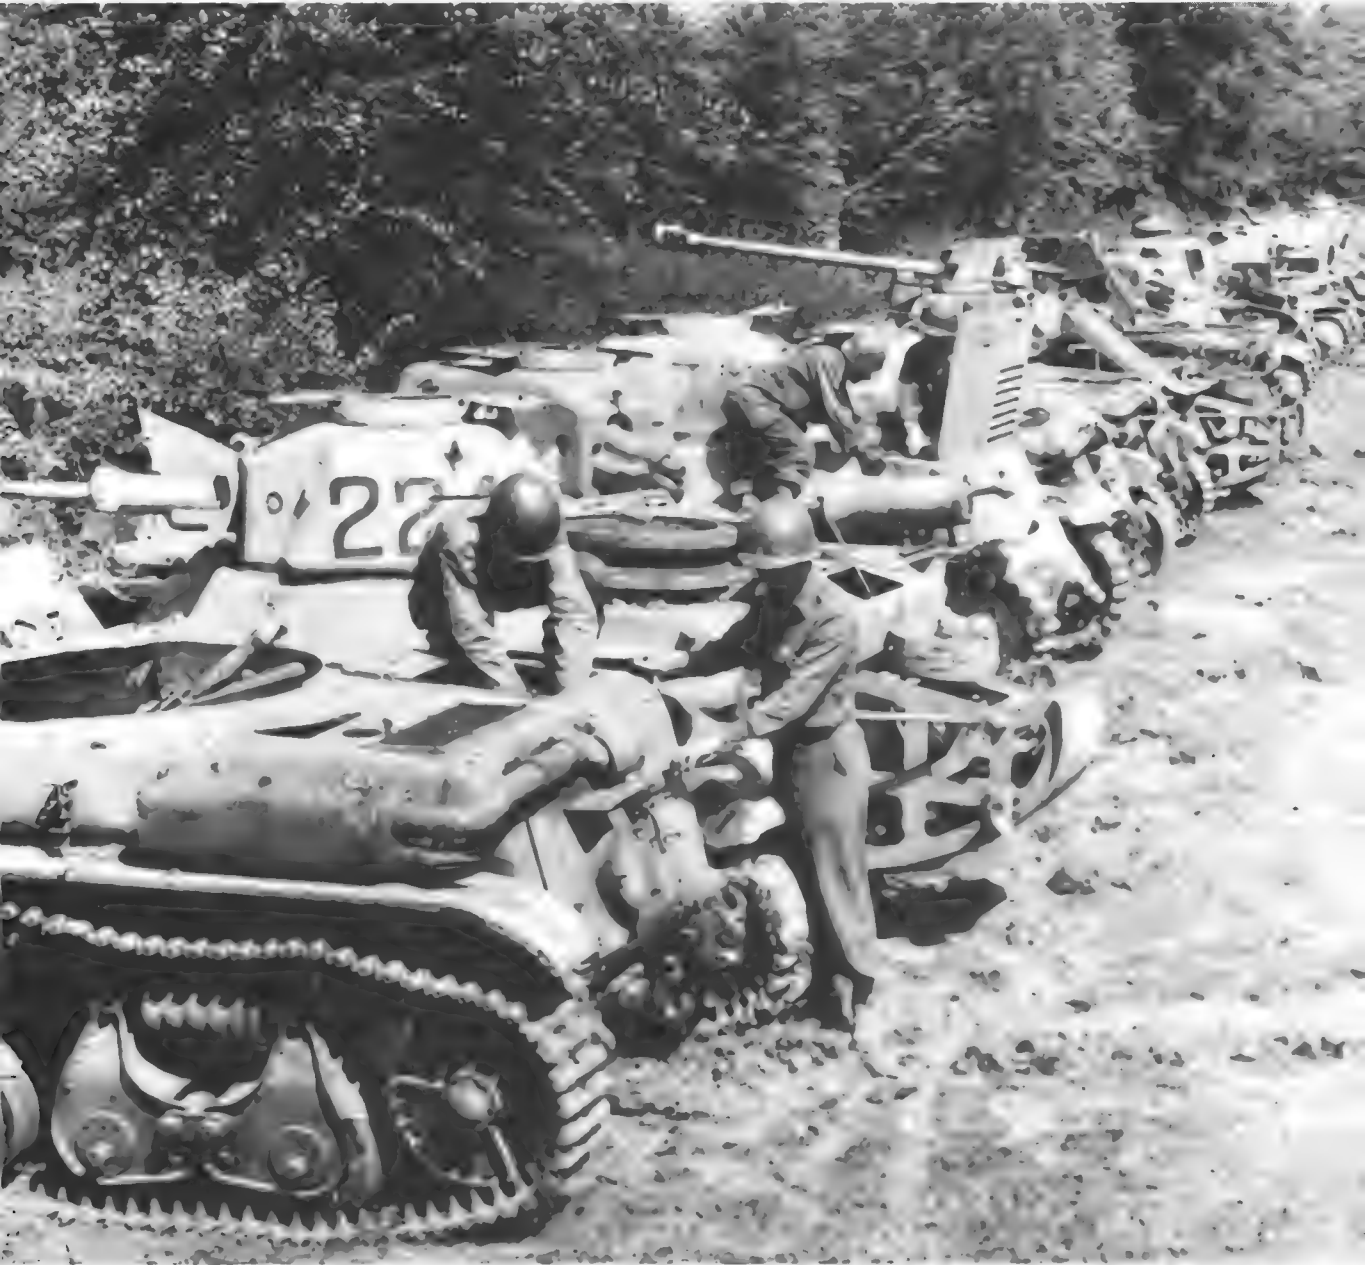
◀34 ▲35

34. Front view of a Jagdpanzer IV. The series went from 60mm superstructure to an 80mm one. This one still has the 60mm plate, but the MG port on the left side has been welded shut, in anticipation of its complete deletion later on when the longer gun was introduced. Note the zimmerit and the threads for the discontinued muzzle brake. (Author's collection)

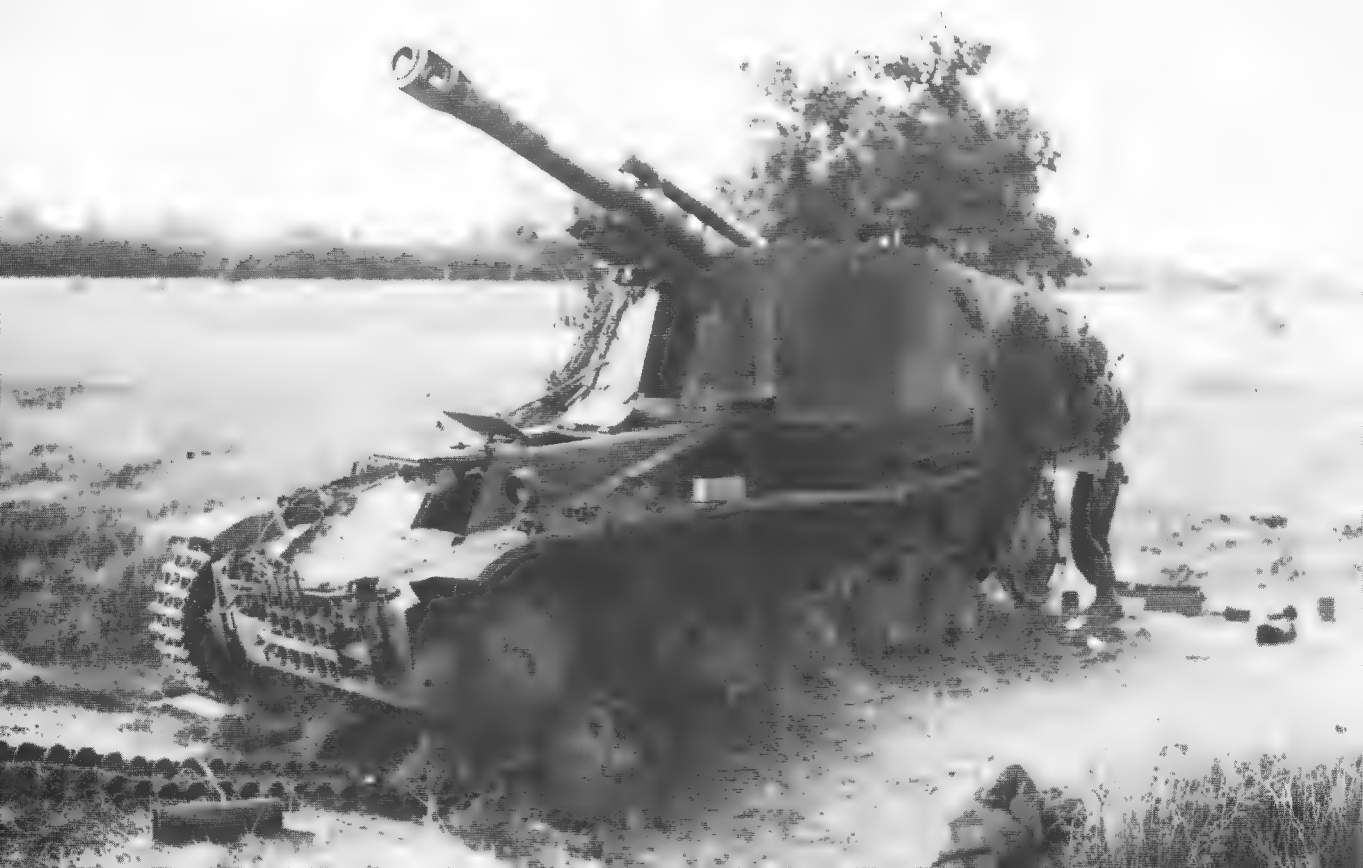
▼36

36. This 'Wespe' was destroyed by American troops at Mortree, France, 16 August 1944. Mounting the 10.5cm light field howitzer in a modified Pz Kpfw II chassis, it was a more economical SP than the American 'Priest'. The driver's compartment is shown completely opened up, and the SP artillery tactical symbol is just visible in front of the sprocket.

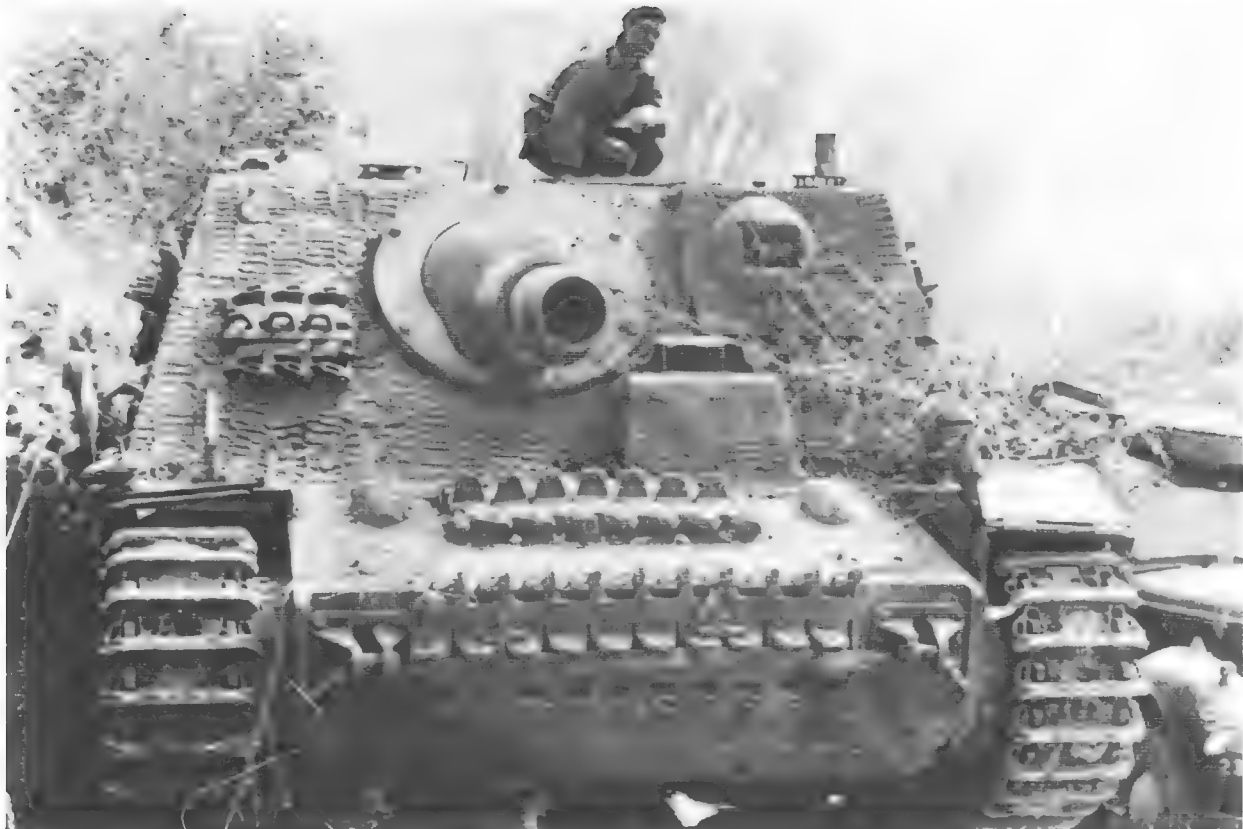
37▲ 38▼

37. A Sturmpanzers IV from the last production series is gone over for booby-traps after being abandoned. This 'Brummbär' is fitted with the auxiliary MG in the front superstructure and the box for the driver, giving only periscopic vision. Track links dot the heavy coating of zimmerit. (Author's collection)

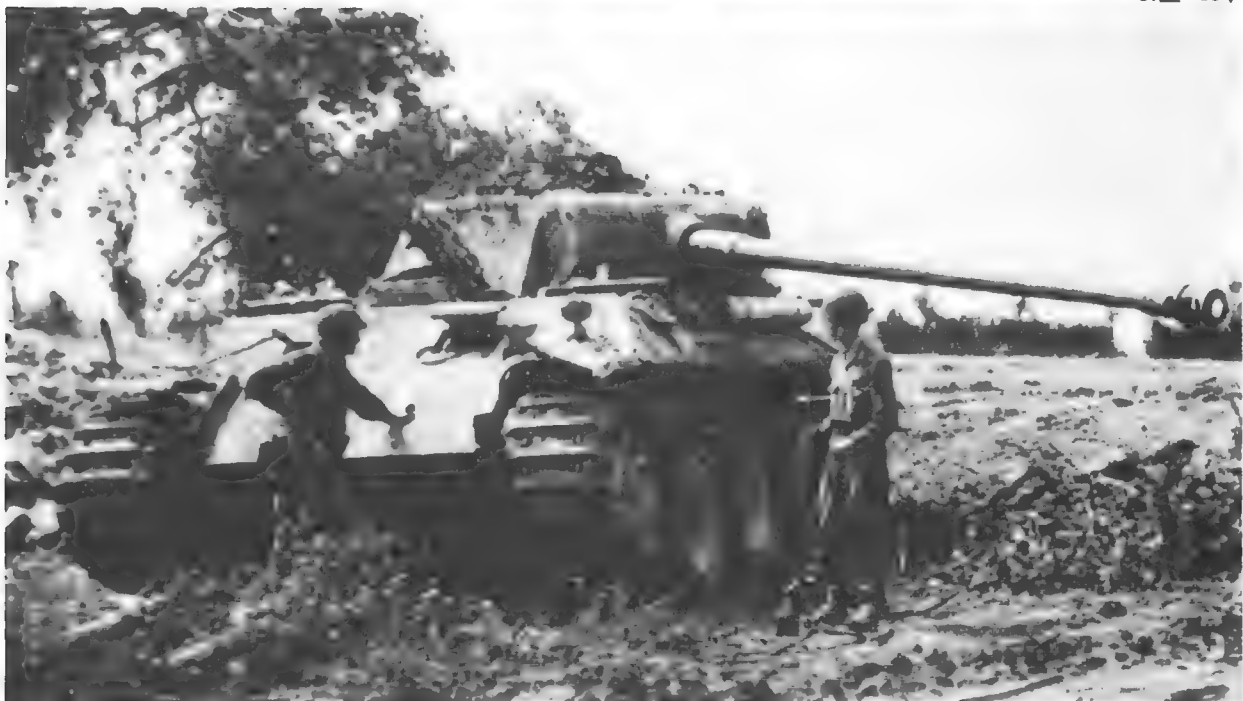
38. GIs look over a Panther Ausf A which appears to have been holed through its glacis, an extremely difficult thing to do at any range. The main gun was probably tracking a flanking vehicle when a tank destroyer or 'Firefly' drilled it. Note the troop-applied zimmerit. (Author's collection)
